**Draft  
Environmental Assessment**

# **Ruby Creek Stream Channel Restoration**

Ruby Creek Stream Channel Relocation Permit Drawings

McAtee Homestead Cultural Assessment

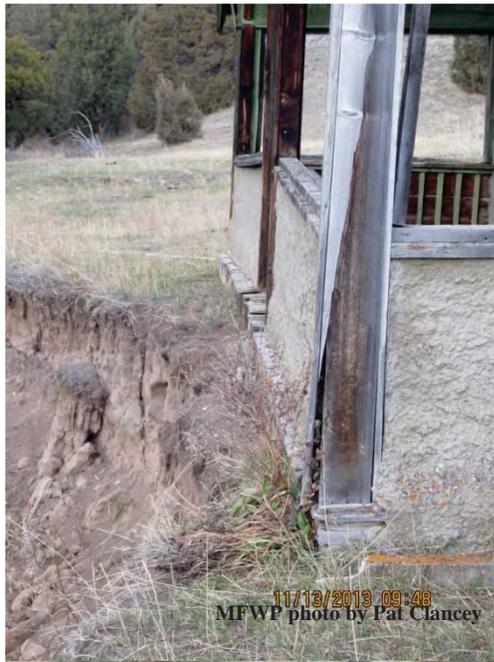
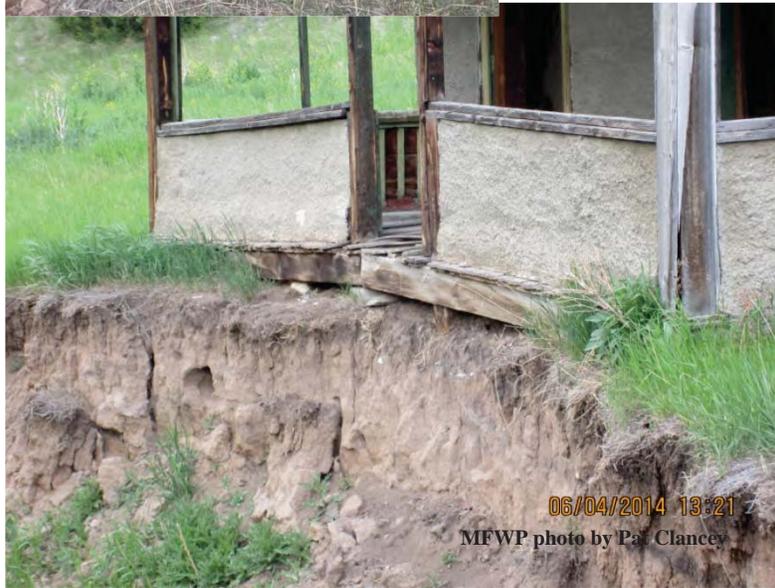
Figure 2. Photos illustrating streambank erosion at the historic McAtee homestead, November 2013 (top) vs July 2014 (bottom).

Ruby Creek is an approximately 15-mile long stream in the Gravelly Mountain Range with four named tributaries (Figure 1). Of these four, only the South Fork of Ruby Creek is perennially flowing. The site of the proposed action is on the mainstem of Ruby Creek downstream of all tributaries, but upstream of the only irrigation headgate on the stream. The irrigation headgate is approximately ½ mile downstream of the proposed project site, at the mouth of a small canyon. The canyon walls constrict in the area of the headgate, which could be a potential site for debris to accumulate if the historic McAtee homestead were to crumble into the stream and be carried downstream. The structure is being actively undercut (Figure 2). When first observed in 2011, a strip of ground wide enough to walk across remained between the porch of the cabin and the streambank, but that strip

has collapsed into the stream over the past 3 years, and most notably since Fall 2013. The cabin is constructed of materials such as timbers (Figure 3), boards, bricks and chicken wire that could potentially cause the active stream channel to become plugged, causing further lateral erosion or down cutting of the channel. The homestead is one of several structures at the site (Figure 4).

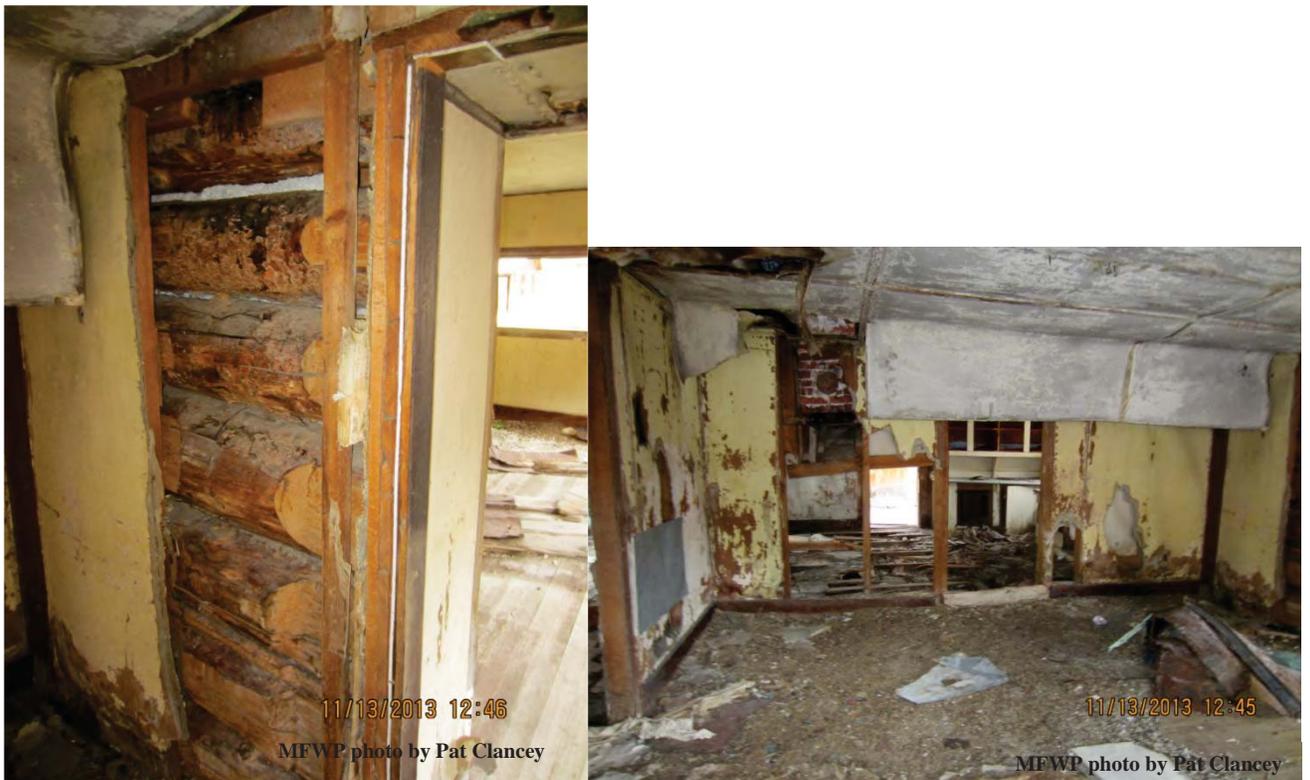
Figure 3. Photos of the interior of the McAtee homestead, showing original timbers used in construction of the walls and other construction materials.

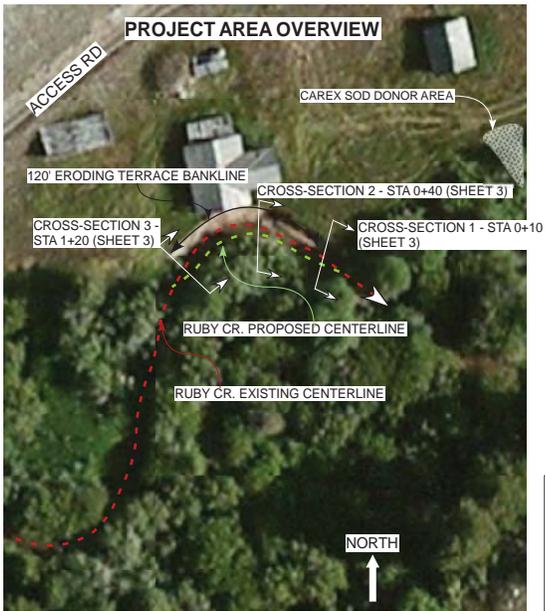
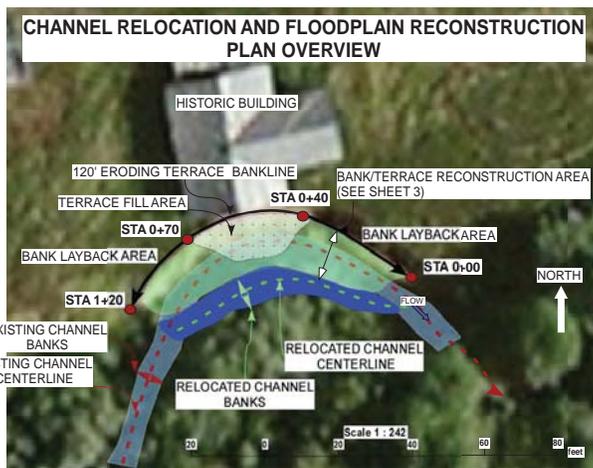
- GENERAL TREATMENT NOTES:**
1. RELOCATE CENTERLINE CREEK APPROX. 15 FT SOUTH OF CURRENT POSITION WHERE IT IS UNDERMINING HISTORIC STRUCTURE.
  2. SALVAGE AND REPLANT 30 WILLOWS AND SOD IN NEW ALIGNMENT TO NEW LB FLOODPLAIN
  3. CONSTRUCT BIOENGINEERED LEFT BANK AND OVERBANK TERRACE. LAYBACK VERTICAL BANKS, TOPOSOIL AND INSTALL COIR BLANKET FOR EROSION PROTECTION..
  4. EXISTING CHANNEL LENGTH = 120 FT; NEW CHANNEL LENGTH = 105 FT; MEANDER GEOMETRY AND SLOPE NOT SIGNIFICANTLY AFFECTED.
  5. TOTAL DISTURBED AREA < 0.18 ACRES.

1. OTHERWISE **VERY STABLE**, THICKLY VEGETATED CHANNEL HAS MIGRATED INTO A TERRACE THREATENING TO UNDERMINE HISTORIC STRUCTURE.
2. CHANNEL SLOPE = 0.56%
3. SUBSTRATE: D50 = 4", D85 = 9", DMAX = 12"
4. BANKFULL TOPWIDTH = 12 FT; DEPTH 2.15 FT
5. BASEFLOW 11 CFS; BANKFULL Q APPROX. 50 CFS.
6. ERODING LEFT BANK IS 120 LF ; NEAR VERTICAL 6 - 8 FT FACE.

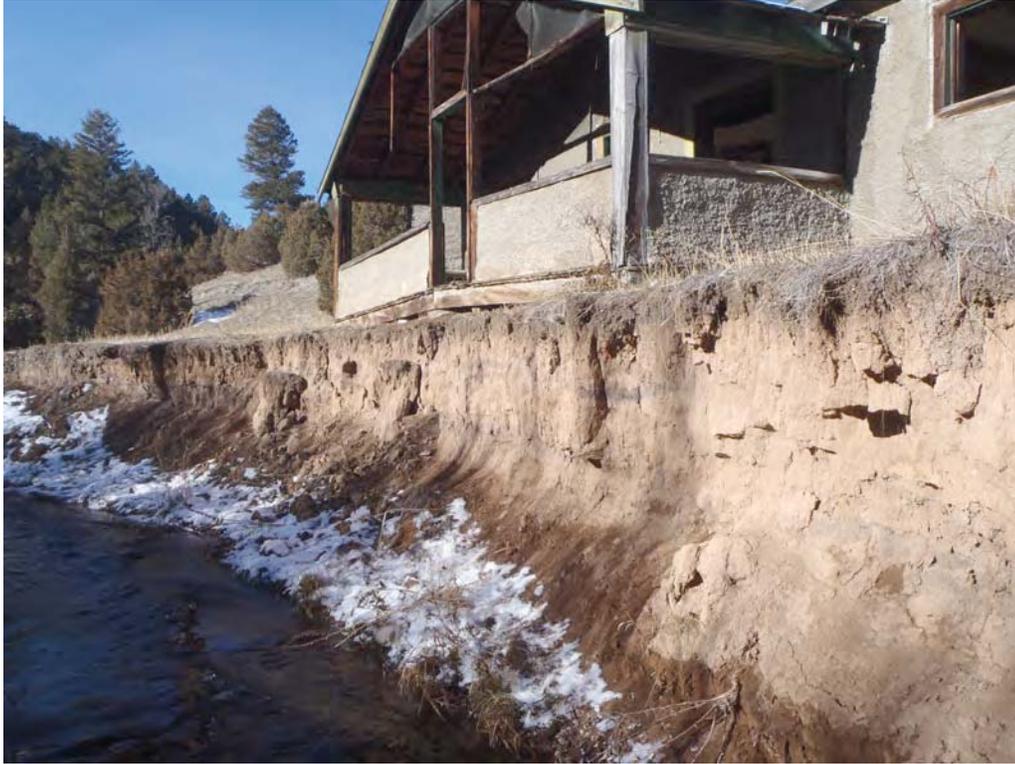
Figure 4. View of the cut bank area at the edge of the McAtee house, facing west. Dark soil horizons represent cultural strata at about 40 and 80 cm below surface (Ferguson 11/27/13).

The prehistoric component was observed in a 1.5 meter high by 20-meter long cut bank on Ruby Creek. Exposed in the vertical cut bank are three distinct bands of organic or charcoal laden soil. The upper of these putative cultural horizons is from 5 to 10 cm thick and consists of a dark gray to very dark gray soil from 10 to 20 cm below the present surface of the terrace. Within this horizon was observed two pieces of rapidly cooled white quartzite. Within the sod roots immediately above this dark soil horizon are pieces of tin and glass, likely associated with the McAtee occupation. A second dark gray soil horizon is seen at about 40 cm below surface. Heat-altered white quartzite was observed in this stratum. A third dark gray soil horizon is seen at about 80 cm below surface. A large bone fragment (probably a bison left calcaneum) is exposed in this stratum, along with white quartzite fire-cracked rock and a couple large rocks that may well be culturally introduced. The fire-cracked rock (FCR) indicates the presence of thermal features in association with these strata. No collections or formal soil profile was made of the cut bank and no testing was performed to try to determine the horizontal extent of the prehistoric cultural deposits. The apparent stratified deposit should be considered potentially significant however, as stratified sites are particularly useful in establishing cultural chronology.

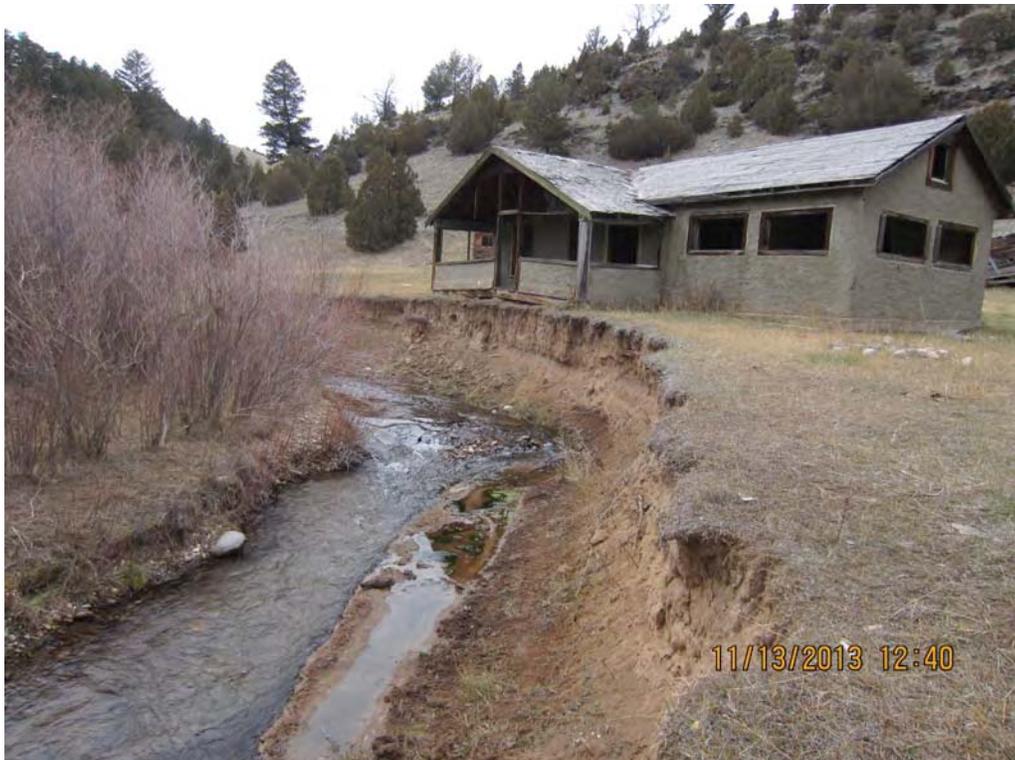
Figure 5. Photo of the cut bank to be stabilized, with Feature 1, (house) of the McAtee Place facing west-northwest (Photo by Pat Clancey, Montana FWP).

The vertical cut bank has eroded to the edge of the porch of the McAtee house and it is the intention of Montana FWP to stabilize this bank. Stabilization would be done by digging a new channel within the flood zone of the creek to the south of the present channel and using the removed stream bed material as fill to develop a sloping grade in front of the vertical cut bank. Willows would be planted on the re-contoured slope for long-term stabilization.

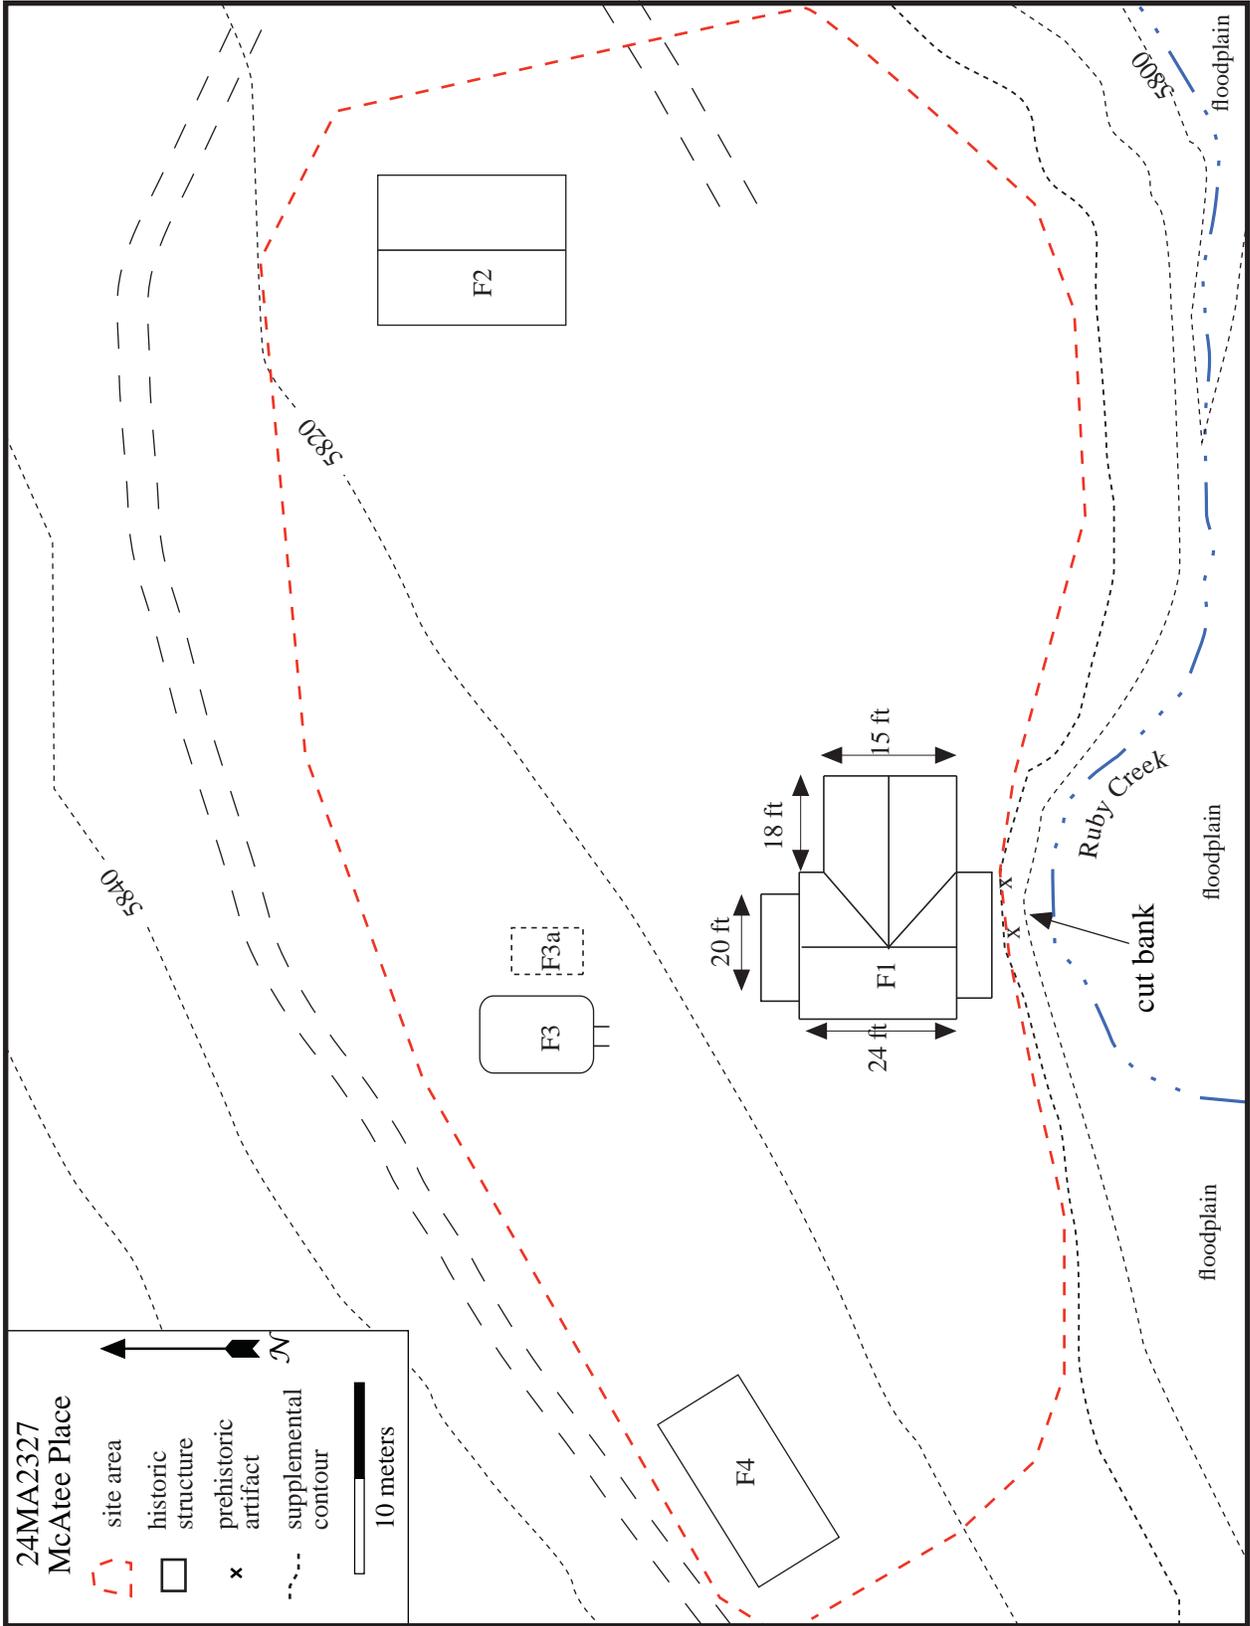
Figure 6. Sketch map of site 24MA2327, the McAtee Site.

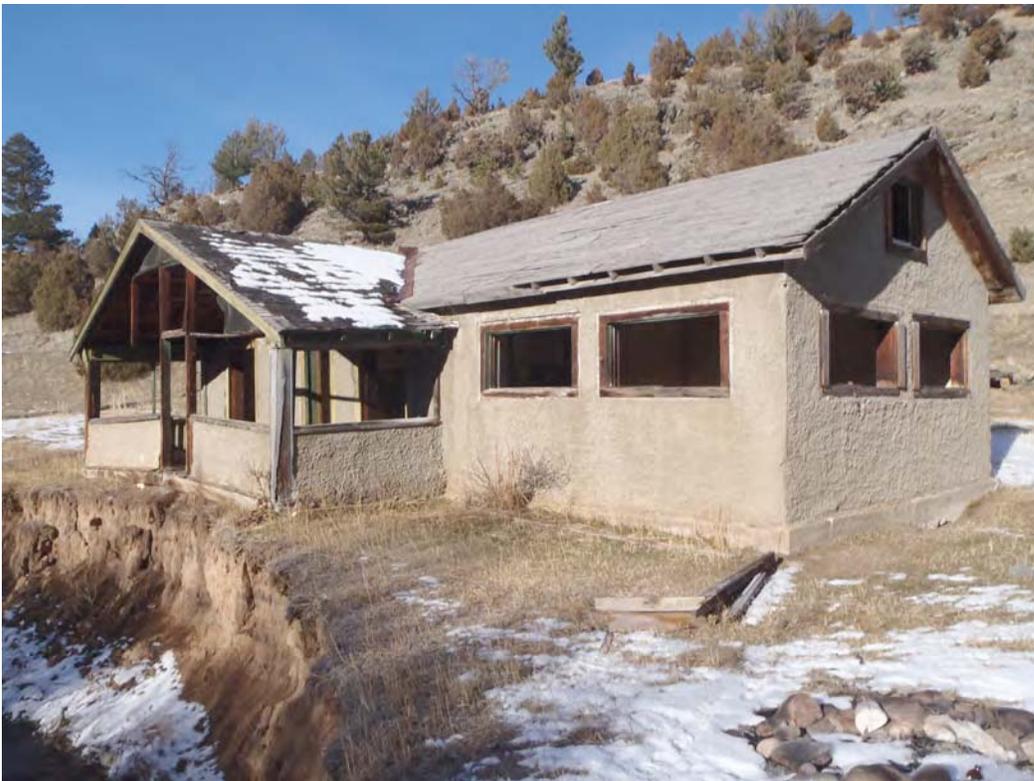
Feature 1, viewing west-northwest showing erosion near structure (PB260146.JPG, Ferguson 11/27/13).

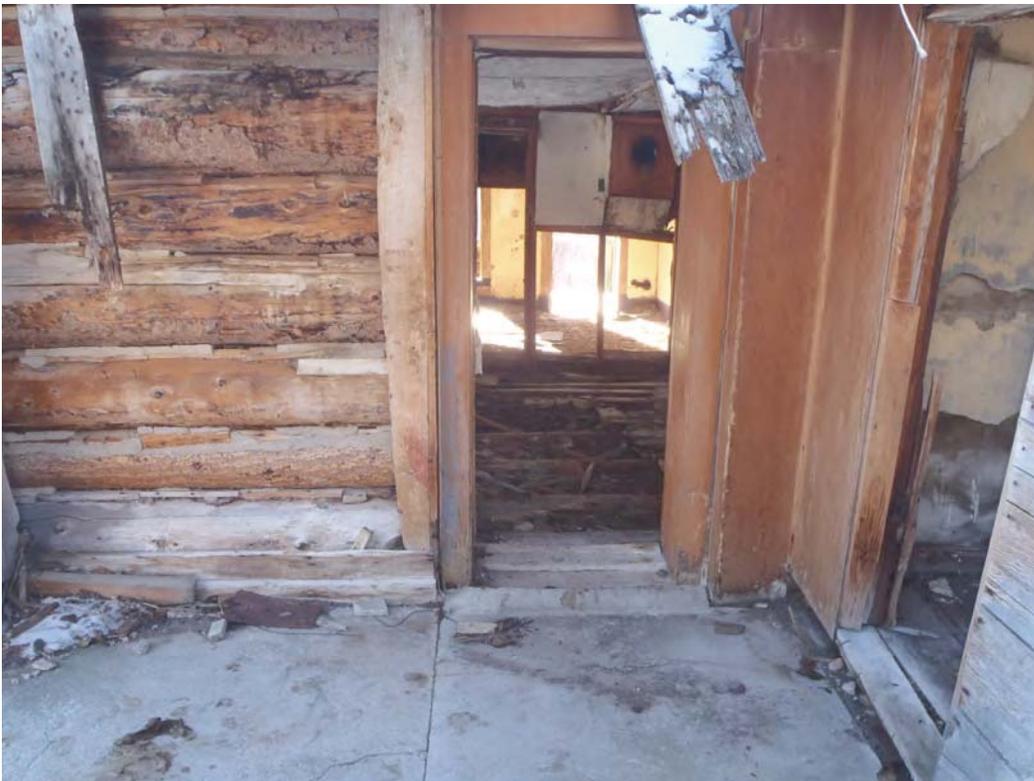
Feature 1, interior detail showing log component, viewing south into north side shed addition (PB260140.JPG, Ferguson 11/27/13).

Feature 1 is the house or residence, a single story structure with an intersecting gable roof, a shed roofed porch and a shed addition. The house was originally a log structure to which framed additions were added. The interior log walls are exposed where plaster has fallen away. The logs were caulked with mortar but the corner joint type is not visible. The house has a concrete foundation, at least on the newer additions. It has framed exterior walls covered with concrete stucco applied over a woven wire foundation. The roofing is wood shakes. The rafters are covered at the eaves. The shed-roofed, screened-in porch is found on the south side and is 22 ft long by 7 ft wide. A 20 ft by 9 ft shed roof addition is found on the north side. Interior dividing walls are of frame construction. The original log structure was about 24 ft by 24 ft and forms the central part of the structure. The logs are only exposed in small areas so the original log construction technique is not apparent. The interior has a pine wood floor. Window openings consist of a pair of 2 ft by 2 ft (2 light) on the west side, a pair of 2 ft by 4 ft openings on the east side, a pair of 4 ft by 5 ft openings on the south side (opening into the porch), and 2 ft by 2 ft openings on the north and west sides of the shed addition. Entrances are found on the south side porch and on the east side of the shed addition. A wood stove body lies in the structure. The structure appears to be of 1920s-era construction with additions possibly as late as the 1940s.

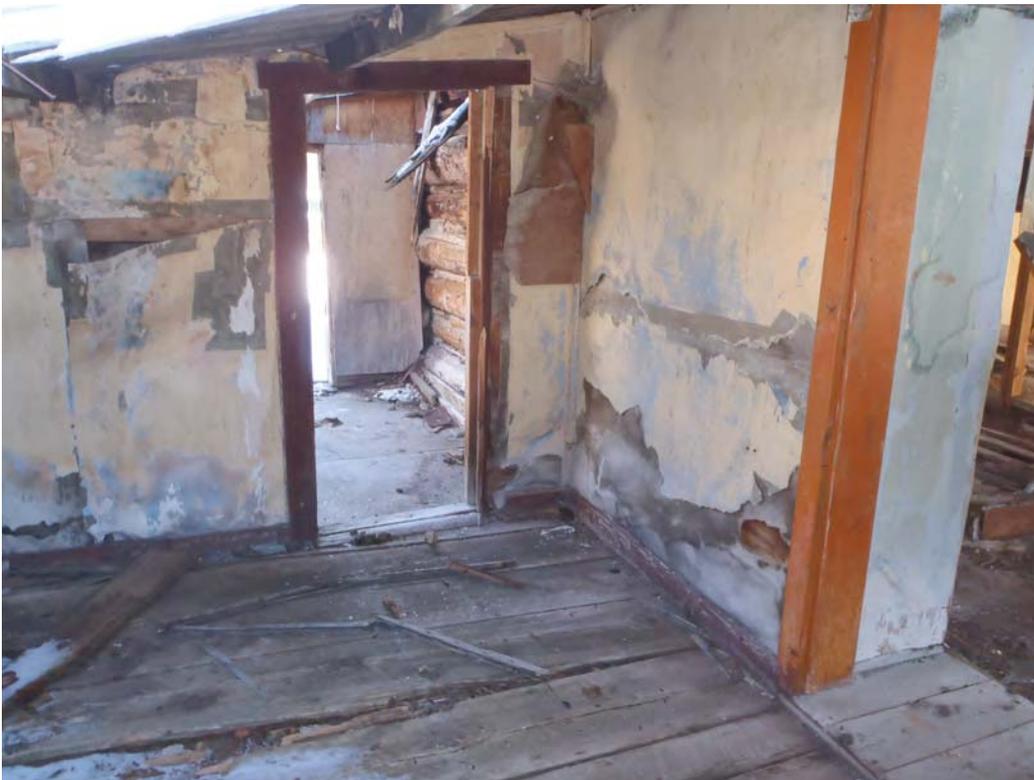
Feature 1, interior detail showing log component, viewing northwest (PB260139.JPG, Ferguson 11/27/13).

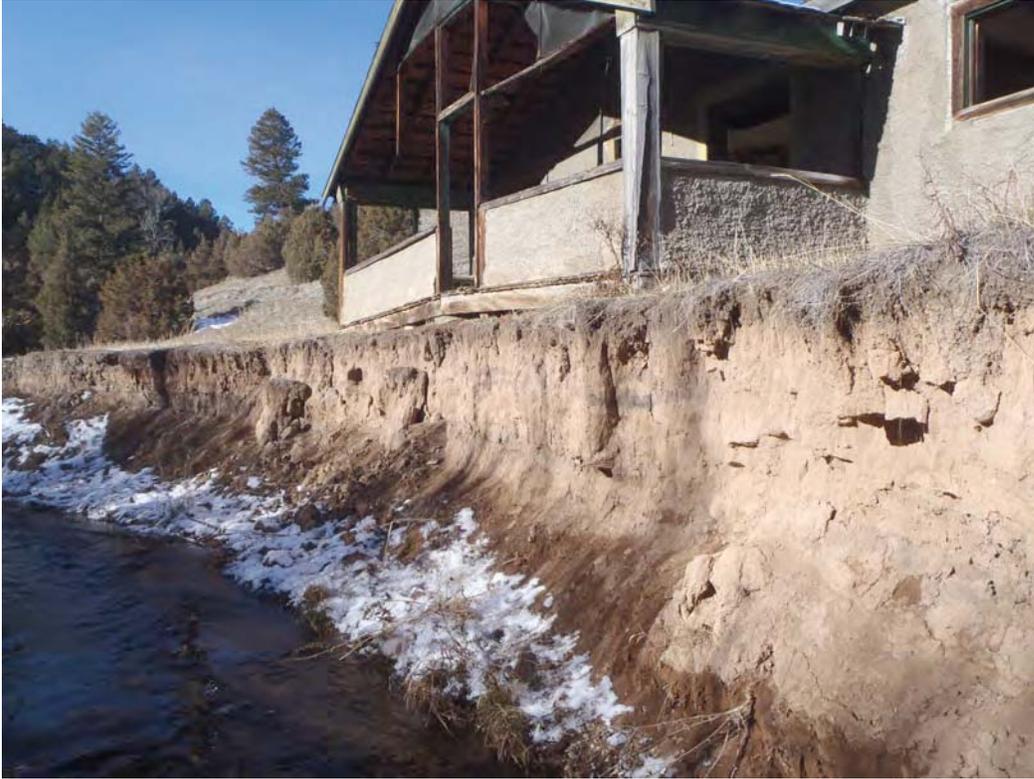
Cut bank viewing east showing dark soil horizons (PB260168.JPG, Ferguson 11/27/13).

The prehistoric component was observed in a 1.5 meter high by 20-meter long cut bank on Ruby Creek. The soil in the cut bank is pale reddish-brown brown silt. Exposed in the vertical cut bank are three distinct bands of organic or charcoal laden soil. The upper of these putative cultural horizons is from 5 to 10 cm thick and consists of a dark gray to very dark gray soil from 10 to 20 cm below the present surface of the terrace. Within this horizon was observed two pieces of rapidly cooled white quartzite. Within the sod roots immediately above this dark soil horizon are pieces of tin and glass, likely associated with the McAtee occupation. A second dark gray soil horizon is seen at about 40 cm below surface. Heat-altered white quartzite was observed in this stratum. A third dark gray soil horizon is seen at about 80 cm below surface. A large bone fragment (probably a bison left calcaneum) is exposed in this stratum, along with white quartzite fire-cracked rock and a couple large rocks that may well be culturally introduced. The fire-cracked rock (FCR) indicates the presence of thermal features in association with these strata. No collections or formal soil profile was made of the cut bank and no testing was performed to try to determine the horizontal extent of the prehistoric cultural deposits. The apparent stratified deposit should be considered potentially significant however, as stratified sites are particularly useful in establishing cultural

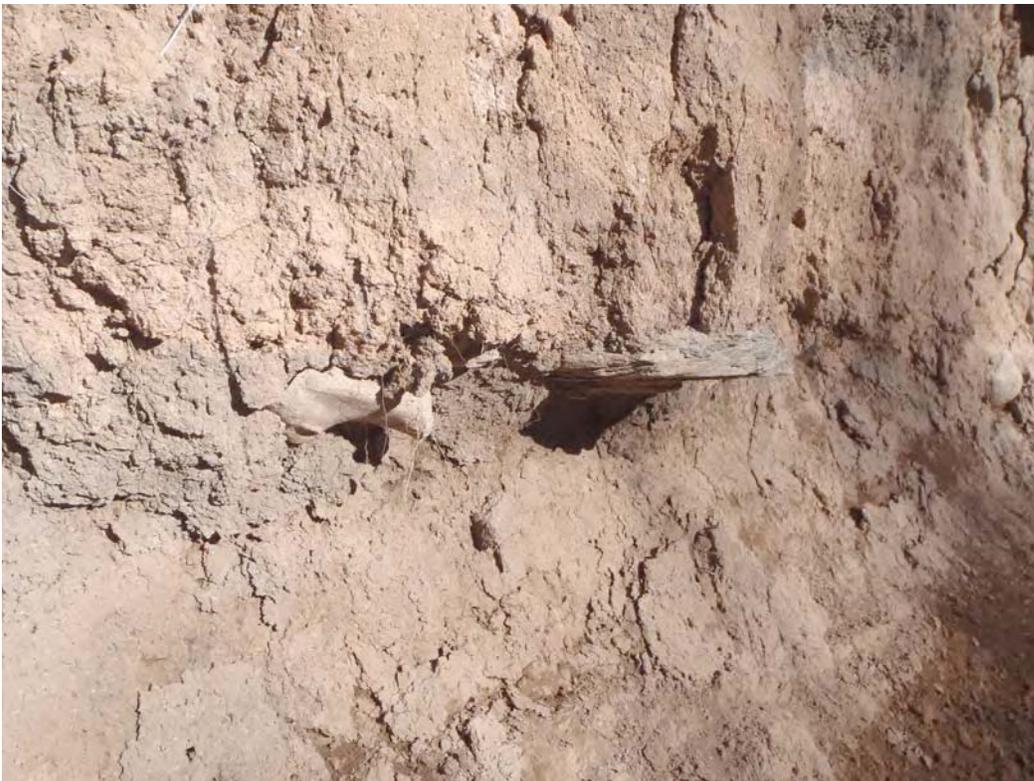
Bison calcaneus in lowest cultural horizon (+/- 80 cmbs) (PB260165.JPG, Ferguson 11/27/13).

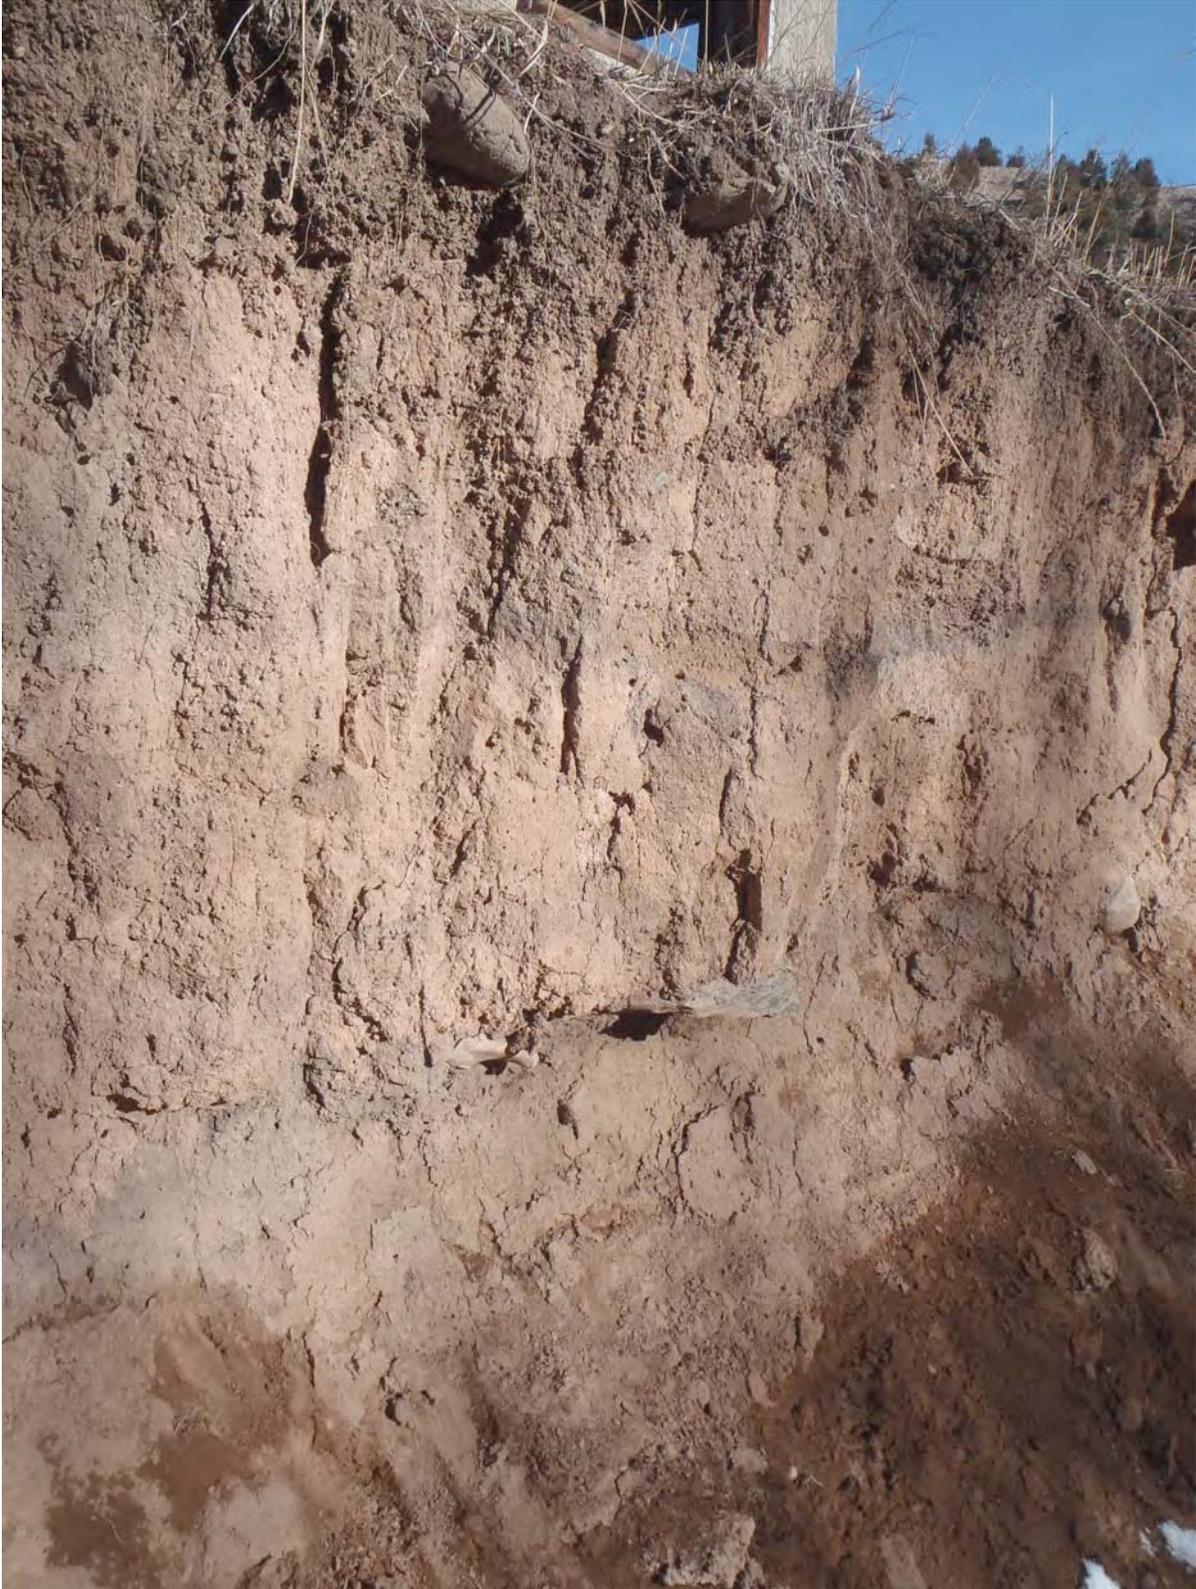
Dark soil horizons in cut bank profile (PB260166.JPG, Ferguson 11/27/13). The upper cultural level (just below the sod layer), and the middle horizon (+/- 40 cmbs), contain white quartzite fire-cracked rock. The lowest level contains a bison calcaneus and probable manuported cobbles.
