# **2010 Governor's Office Assessment of State-Owned Aircraft**

**In Compliance with SJ 22 (2009 Session)**

**A Report to the 62nd Legislature  
October 2010**

Prepared by Joe Brand, Chief Pilot  
Office of the Governor

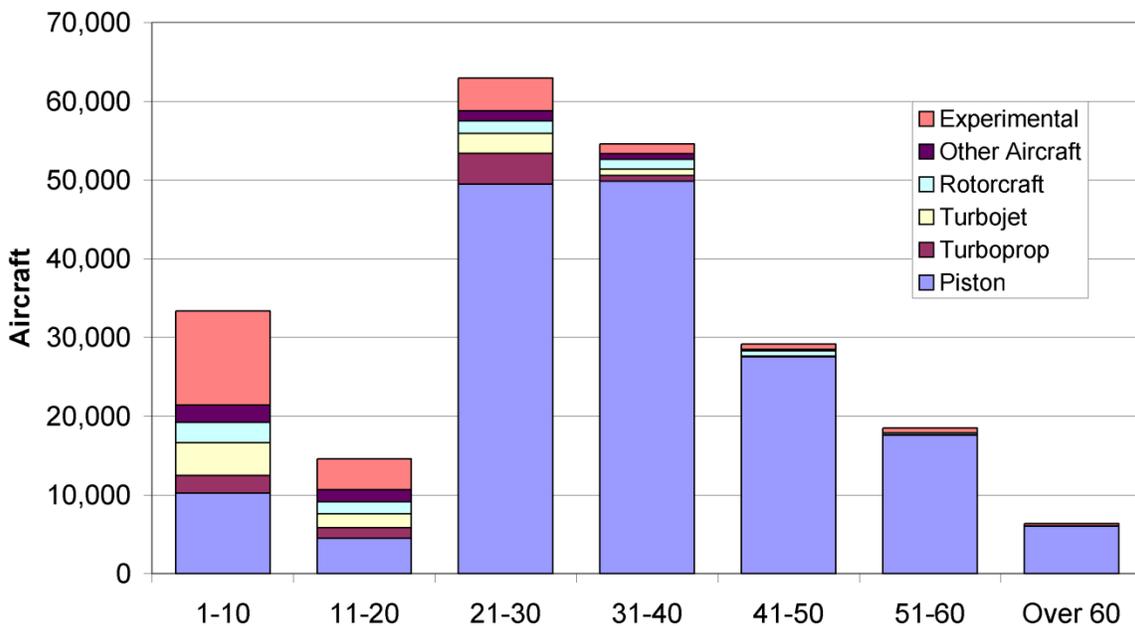
**Count of Active Aircraft  
by Age Bracket and Type - 2004**

The general age of the state fleet may be compared against the national average. The following chart shows the age distribution of the United States general aviation fleet:

The average age of Montana’s fixed-wing fleet is roughly ten years older than the national average. On a national level, the largest percentages of active aircraft are in the 21-40 year brackets, while the majority of the state’s aircraft are in the 31-50 year brackets. As mentioned previously, national data was compiled in 2004, and does not reflect any changes that have developed since then.

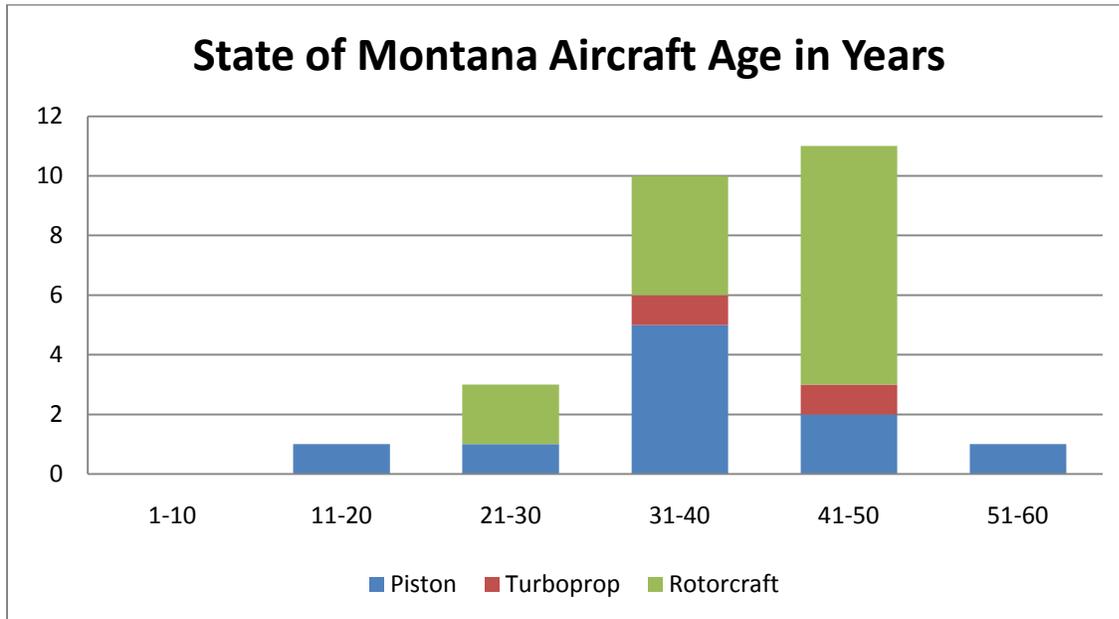
The following chart shows the age distribution of the State of Montana fleet:

The state’s rotor-wing aircraft are considerably older than the national average. These helicopters have all been donated by or are on loan from the federal excess property program. The oldest of these, the five medium helicopters operated by DNRC, have been extensively refurbished and do not present any aging concerns at this time.

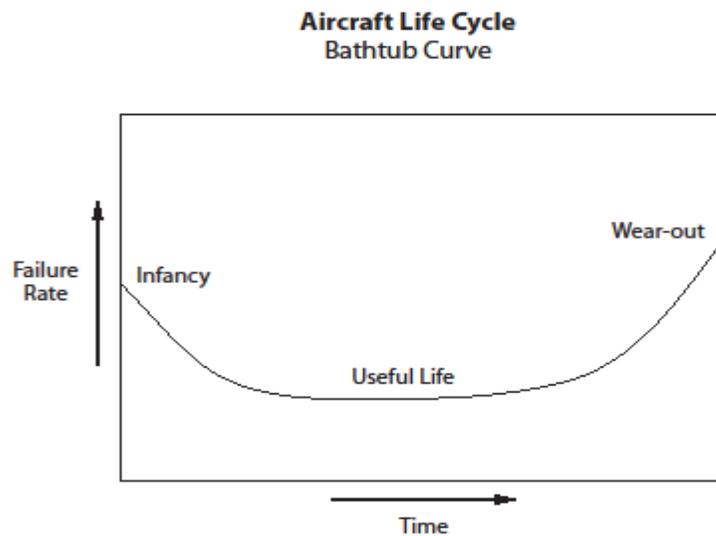
The overall reliability of a system or component throughout its life has been described as following a ‘bathtub curve’. The lifecycle in the bathtub curve, shown in Figure 5, involves three phases:

infancy;  
useful life; and  
wear-out.

During infancy, the failure rate decreases over time, as many failures are due to material flaws or problems in manufacture. This phase is less relevant when considering aging aircraft. In the useful-life phase, failures due to initial flaws gradually decrease while failures due to wear-out gradually increase. Therefore, the average number of failures remains relatively constant throughout the useful-life phase. During the wear-out phase, failures will increase as the product reaches the end of its useful life.
