FUTURE FISHERIES IMPROVEMENT PROGRAM

REPORT TO THE 2011 LEGISLATURE
AND
FISH, WILDLIFE AND PARKS COMMISSION

**Montana Fish,
Wildlife & Parks**

DECEMBER 2010

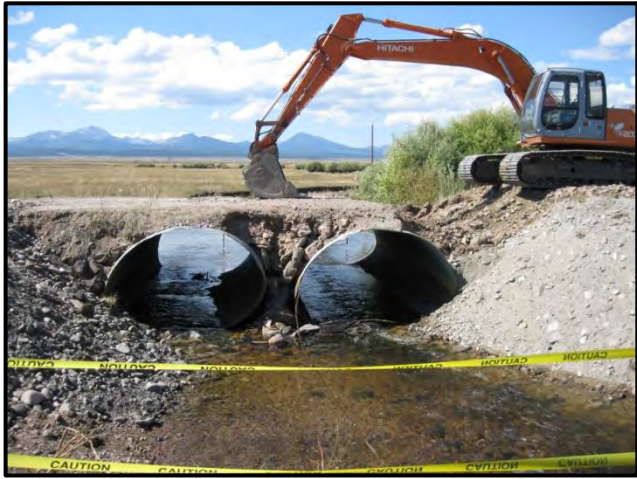
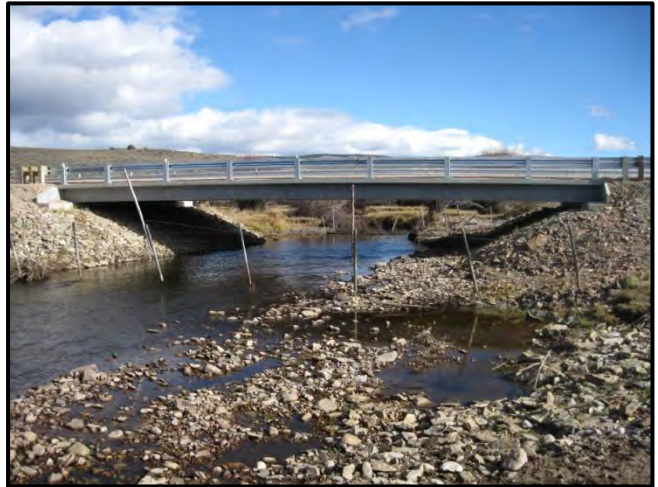
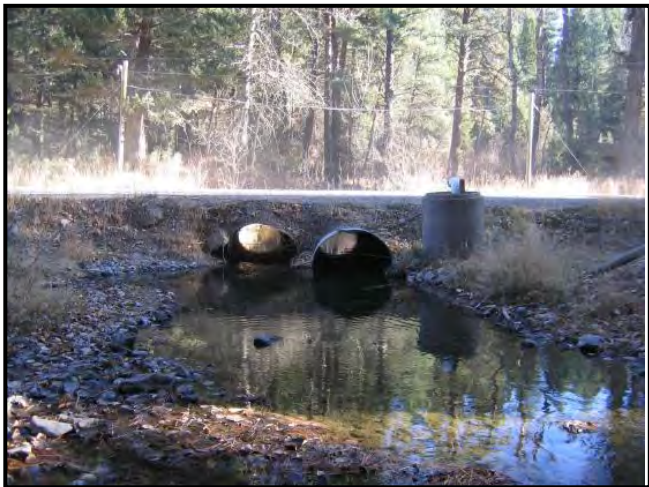
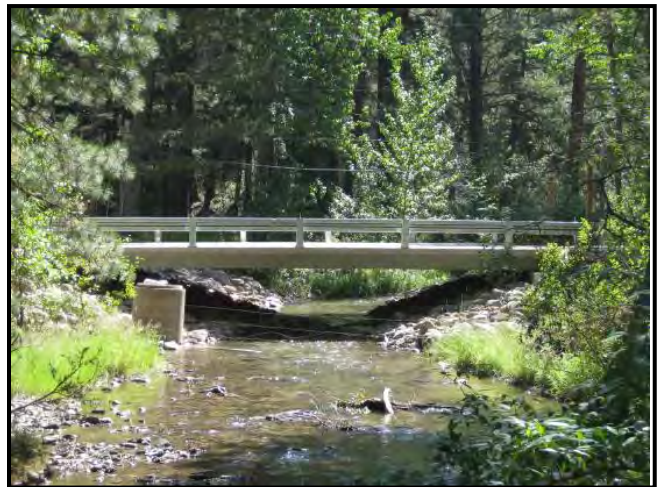
Photo Illustration 1. The upper two photographs display a fish passage enhancement project located on Governor Creek, a tributary to the Big Hole River near the community of Jackson. The project replaced double 6-foot in diameter culverts (upper left photo) with a 64-foot concrete bridge (upper right photo) to the benefit of fluvial arctic grayling, rainbow trout, brown trout, burbot and mountain whitefish. The lower two photographs show a fish passage enhancement project on Poorman Creek, a tributary to the Blackfoot River located near the town of Lincoln. The project replaced a double culvert (lower left photo) with a free span bridge (lower right photo) to enhance fish passage for bull trout, westslope cutthroat trout and brown trout. Upper two photos are courtesy of Jeff Everett, USFWS. Lower two photos are courtesy of Ryan Aasheim, Big Blackfoot Chapter Trout Unlimited.

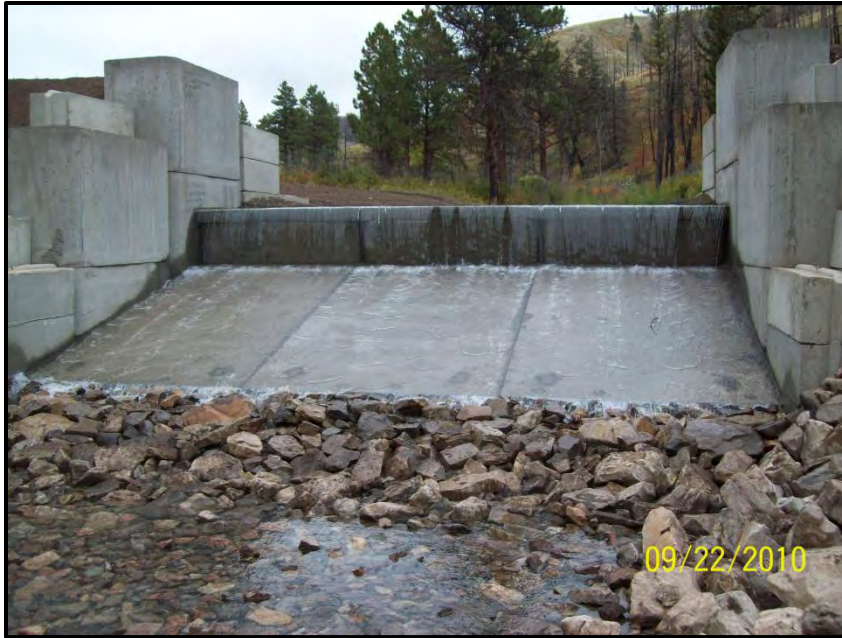
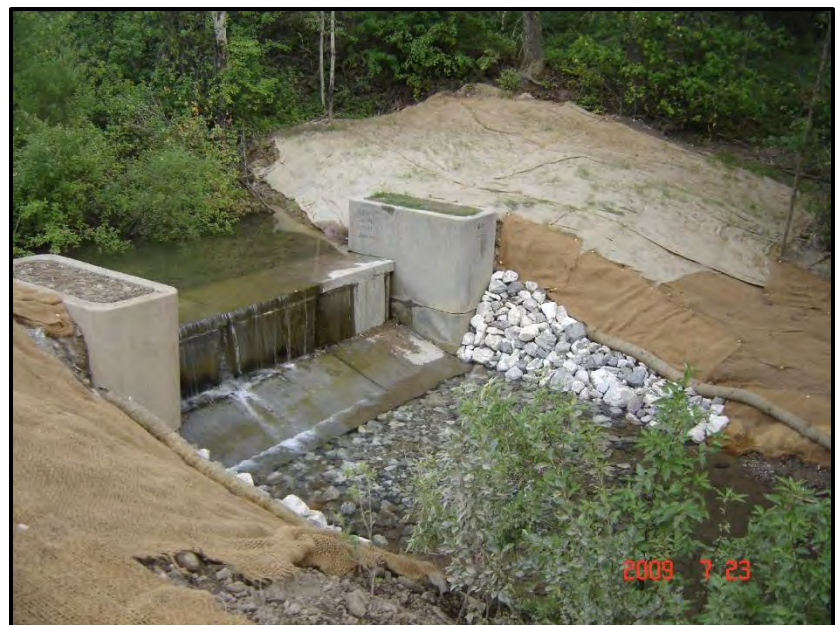
Photo Illustration 2. Fish passage barrier projects constructed on Cottonwood Creek and White Gulch for the purpose of protecting genetically pure westslope cutthroat trout from invasion by non-native fish, including rainbow trout, brown trout and brook trout. The upper photo shows the new fish passage barrier constructed on Cottonwood Creek, a tributary to Holter Reservoir located on FWP’s Beartooth Game Range. The lower photo shows a new fish passage barrier constructed on White Gulch, a tributary to Canyon Ferry Reservoir. The upper photo is courtesy of Allied Engineering. The lower photo is courtesy of Ron Spoon, FWP.

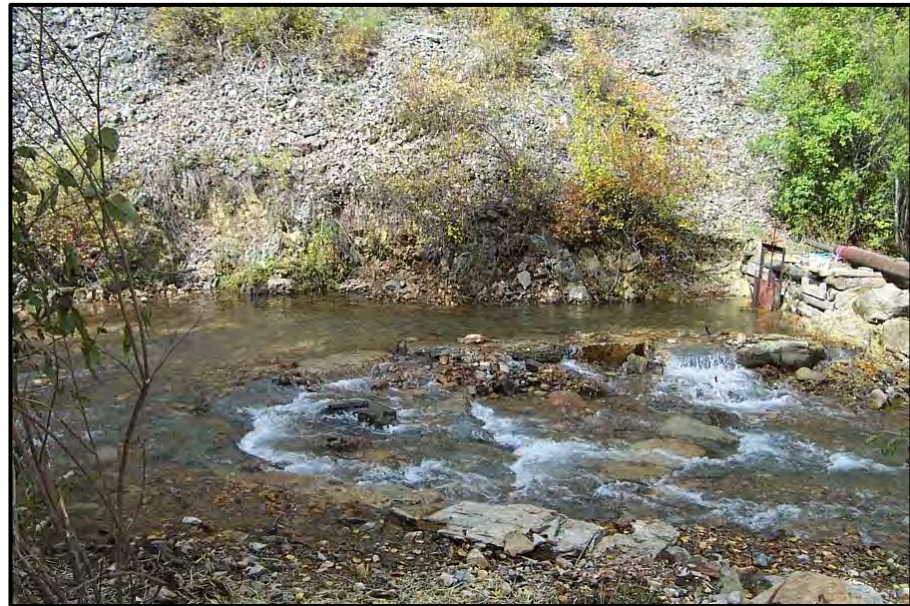
Photo Illustration 3. Upstream fish passage for bull trout, westslope cutthroat trout and sculpins was enhanced on Dry Creek, a tributary to the Clark Fork River located near the town of Superior, to improve access to important spawning and rearing habitat. The upper photograph shows the old wood crib diversion dam creating a hindrance to upstream fish passage. The lower photograph shows the new diversion consisting of three vortex rock weirs that create a series of rock steps, providing ample upstream passage opportunity for fish while continuing to provide the water user their irrigation diversion needs. Photos courtesy of Ladd Knotek, FWP.

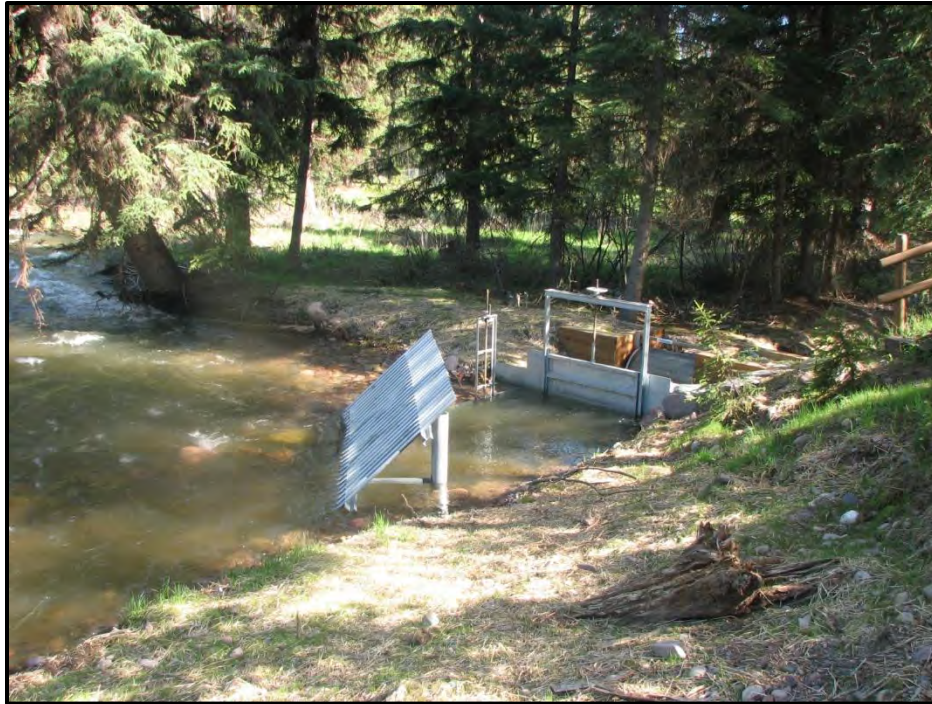
Photo Illustration 4. Fish screens installed on irrigation diversions located on Morrell Creek and Ninemile creeks. Morrell Creek, a tributary to the Clearwater River located near the town of Seeley Lake, supports an important fluvial bull trout population. The Morrell Creek project (upper photograph) involved reducing entrainment into two irrigation canals by installing fish screens, improving upstream fish passage, reducing periodic channel disturbance and enhancing instream flow while continuing to meet the needs of the water user. Ninemile Creek is a tributary to the Clark Fork River located near the community of Ninemile that supports westslope cutthroat trout, rainbow trout, brown trout and mountain whitefish. The Ninemile Creek project involved installation of a coanda style fish screen to prevent entrainment into the irrigation canal and installation of a vortex rock weir to enhance upstream fish passage while meeting the needs of the water user. The lower left photograph shows the Ninemile Creek diversion before project completion. The lower right photograph shows the installed coanda fish screen and vortex rock weir. All photos courtesy of Ladd Knotek, FWP.

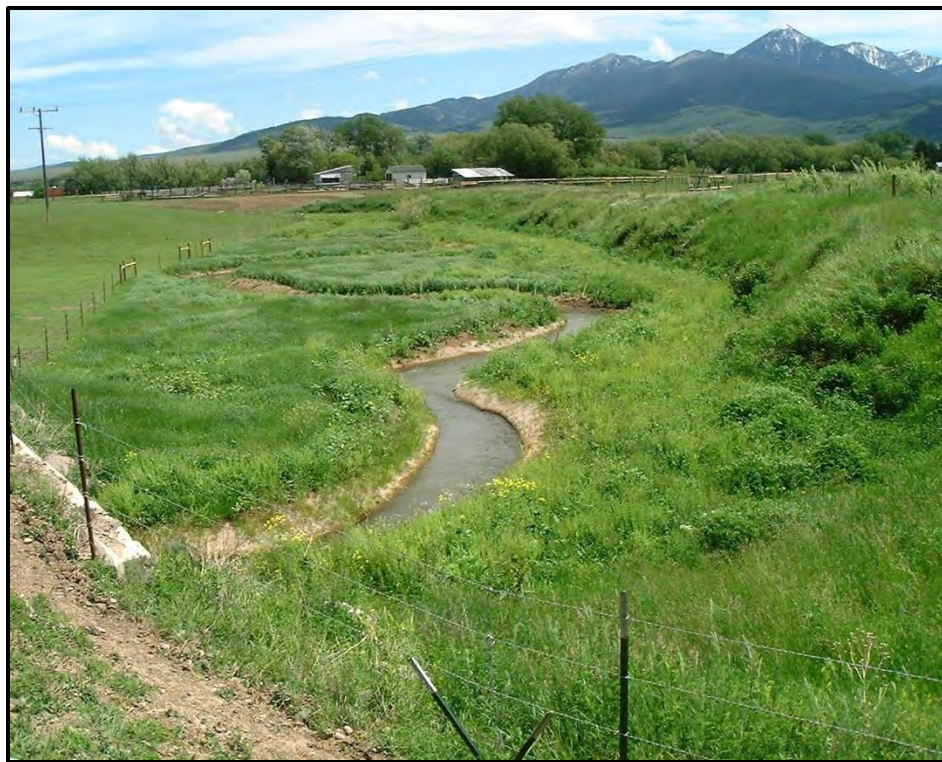
Photo Illustration 5. Channel restoration on Fleshman Creek, a tributary to the Yellowstone River near the town of Livingston. This reach of Fleshman Creek had historically been subjected to channelization and heavy livestock use. This project restored the morphology of 2,400 feet of stream channel and greatly enhanced the floodplain and riparian vegetation while continuing to maintain the agricultural viability of the ranch. The project has benefitted a mixed assemblage of fish including rainbow trout, brown trout, brook trout and Yellowstone cutthroat trout. The upper left photo shows the stream channel prior to restoration. The upper right photo shows the stream channel during construction, including the coir fabric used to form the newly created stream banks. The lower photo shows the restored channel following one growing season with the exclusion of all livestock.

4. Fleshman Creek Channel Restoration. Fleshman Creek (Park County), a tributary to the Yellowstone River near Livingston, supports a mixed salmonid assemblage. Portions of the stream have been substantially degraded as a result of channelization and historic overgrazing by livestock. This project involved restoring a 2,400-foot stream reach, as it flows through the Voyich Ranch, by reconstructing a relatively narrow, deep and sinuous channel and by re-vegetating the riparian corridor. The restored stream channel and streamside areas were protected with riparian fencing and the installation of off-site water for livestock. **Completed.**

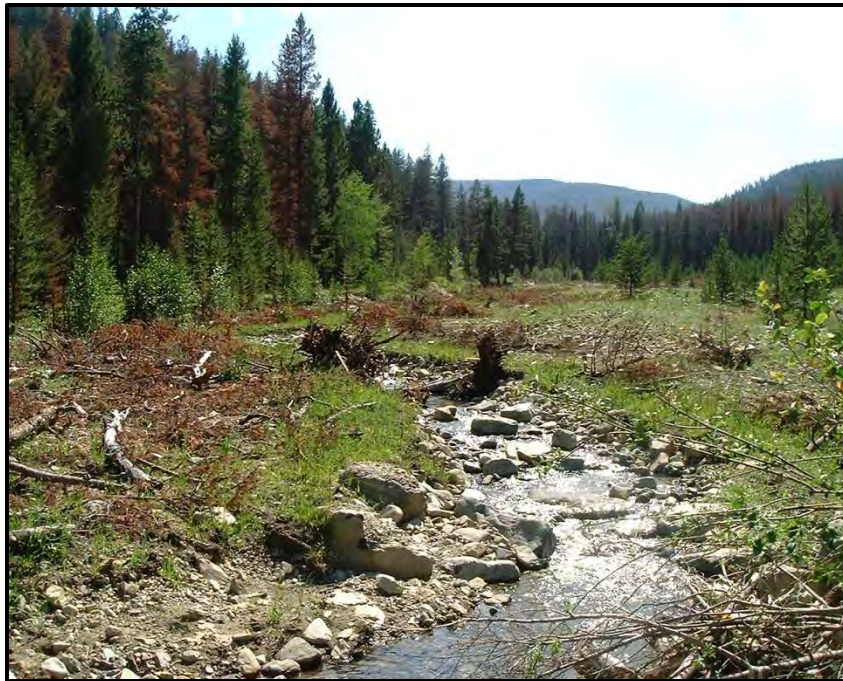
Photo Illustration 6. Channel restoration on Sauerkraut Creek, a tributary to the Blackfoot River located near the town of Lincoln. The stream supports fluvial westslope cutthroat trout and bull trout. This reach of stream has a long history of placer mining and has been channelized and disconnected from the floodplain with placement of an earthen berm. Population densities of fish have been documented to be substantially lower within this channelized reach than in less altered portions of the stream. This project involved restoring the dimensions, pattern and profile of a one mile reach of straightened channel and reactivating the floodplain by removing the berm. The upper left photo shows the old straightened channel with poor fish habitat, confined by the earthen berm on right hand side. The upper right photo shows workers removing the berm. The lower photo shows the very recently restored stream channel that now has connection with its floodplain. The upper two photos are courtesy of Ryen Aasheim, Big Blackfoot Chapter Trout Unlimited.

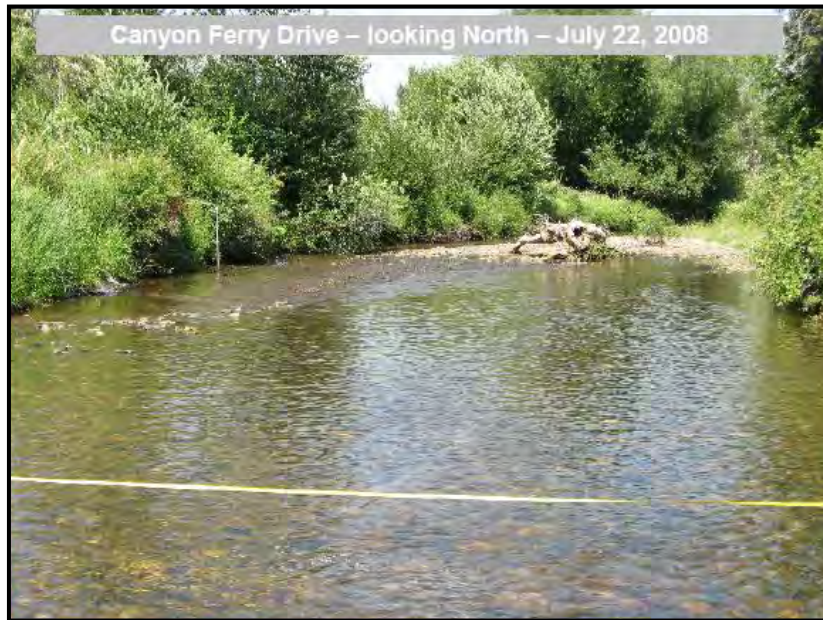
Photo Illustration 7. Re-watering a chronically dewatered reach of Prickly Pear Creek, a tributary to Lake Helena located near the town of East Helena. This project involved a series of water trades between the Helena Valley Irrigation District and the Prickly Pear Water Users which resulted in the reduction of water being diverted from two senior irrigation diversions, thus ensuring in-stream flow remained in Prickly Pear Creek. Historically, this reach of Prickly Pear Creek was totally dewatered during the peak of irrigation almost every year. This project has kept water in the stream year-round and has benefitted rainbow trout and brown trout. The upper photo shows the stream reach entirely dewatered. The lower photo shows the results of the water trades. Photos are courtesy of Rankin Holmes, Clark Fork Coalition.

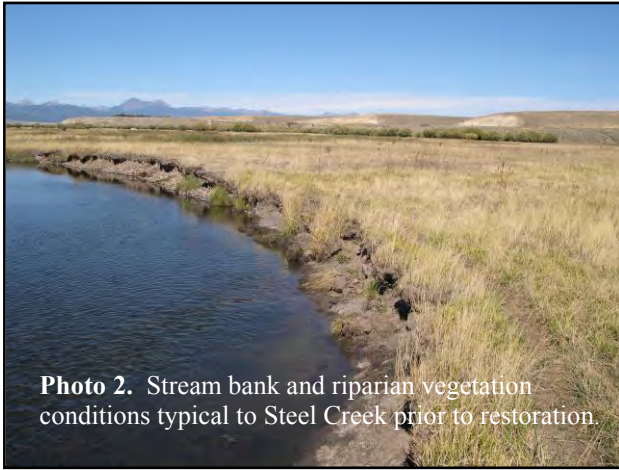
Photo 2. Stream bank and riparian vegetation conditions typical to Steel Creek prior to restoration.

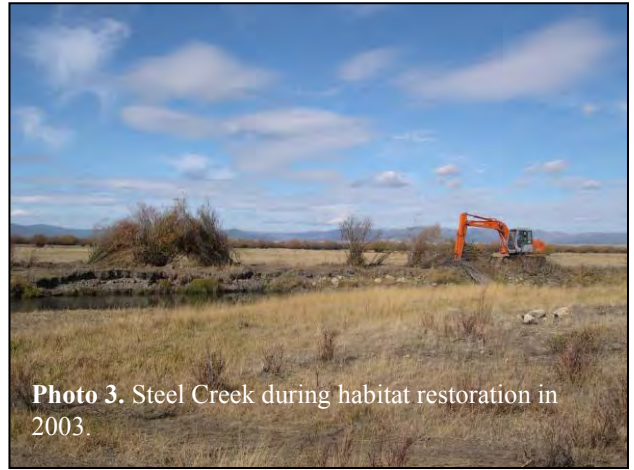
Photo 3. Steel Creek during habitat restoration in 2003.

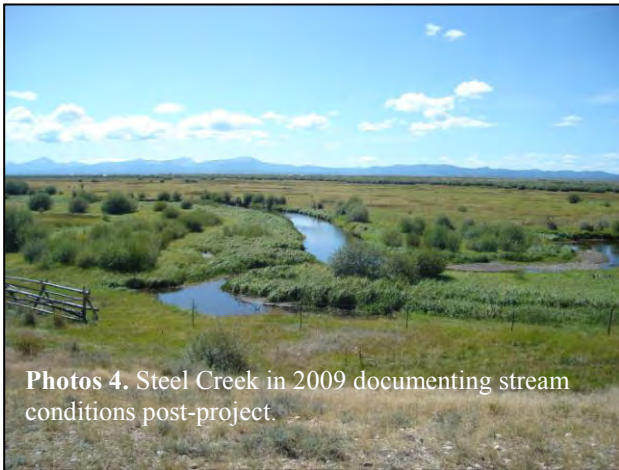
Photos 4. Steel Creek in 2009 documenting stream conditions post-project.

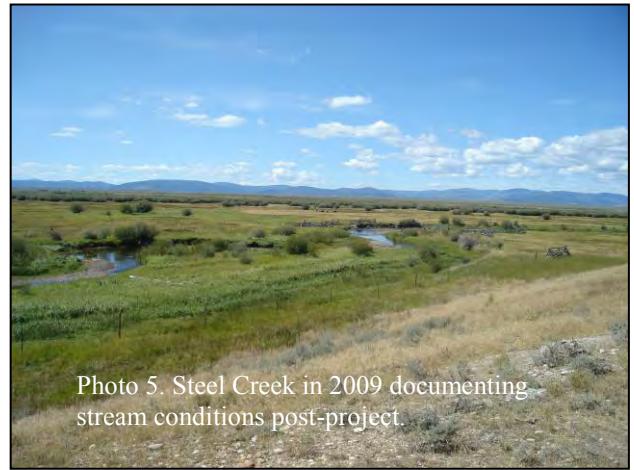
Photo 5. Steel Creek in 2009 documenting stream conditions post-project.

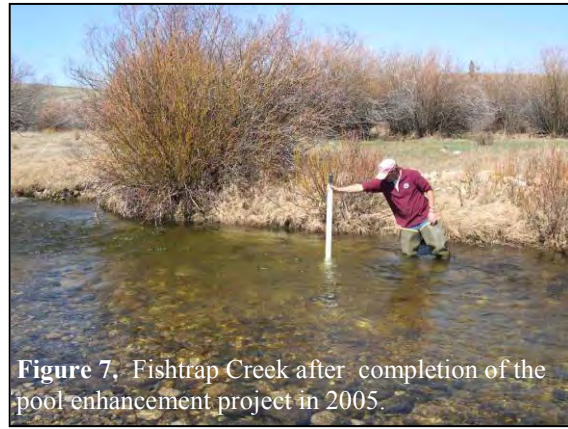
Figure 7: Fishtrap Creek after completion of the pool-enhancement project in 2005.

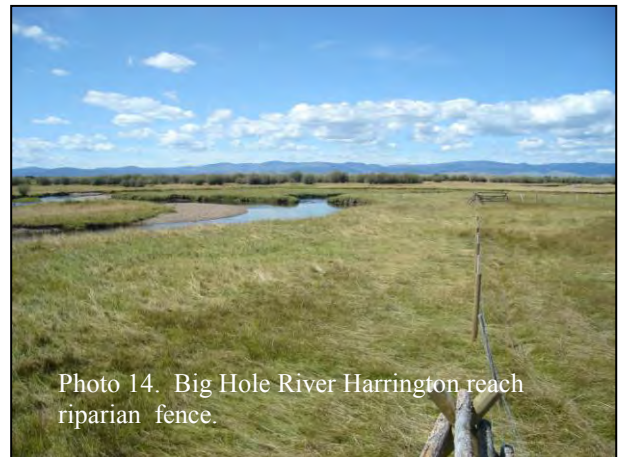
Photo 14. Big Hole River Harrington reach riparian fence.

Brief Project Description: In 2008, nearly five miles of riparian pasture fence was constructed along a 2.25-mile reach of the Big Hole River two miles north of Wisdom, MT. This reach of the Big Hole River is considered critical Arctic grayling spawning and juvenile rearing habitat. Two large pastures were divided into five pastures, including two riparian pastures. The new pasture configuration will be incorporated into a grazing management plan as a component of a Big Hole CCAA conservation plan for the property.

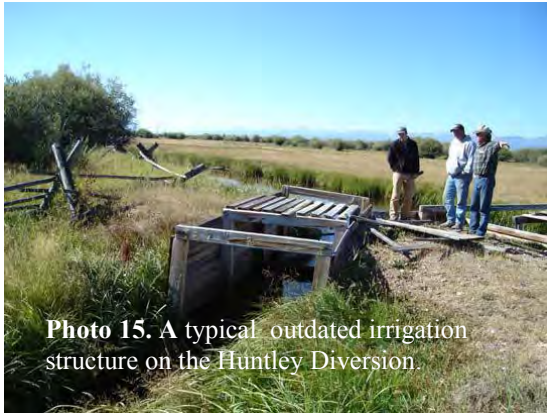
Photo 15. A typical outdated irrigation structure on the Huntley Diversion.

Project summary: In 2007, FFIP collaborated with the NRCS, DNRC, and Ralph Huntley to fund a project to replace three non-functioning diversion structures and four headgate structures on Ralph Huntley and Son, Inc. property. The project also installed two irrigation water-measuring devices in the associated irrigation systems. The project will improve the landowners' ability to control and quantify the amount of water diverted from the Big Hole River. A flow agreement is being developed as a component of the Big Hole CCAA conservation plan for the property.

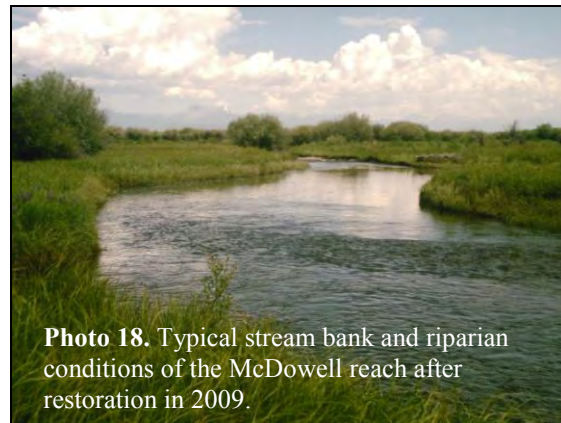
Photo 18. Typical stream bank and riparian conditions of the McDowell reach after restoration in 2009.

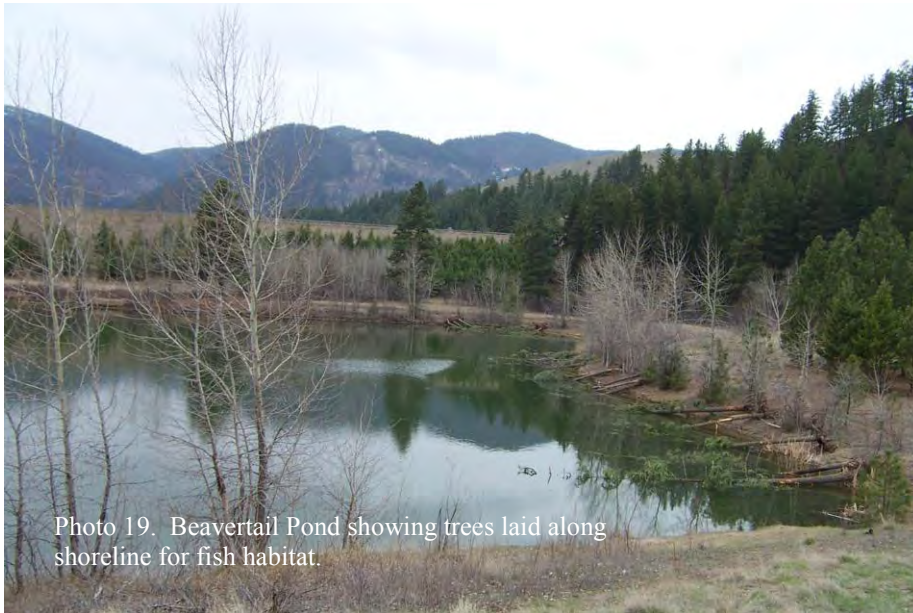
Photo 19. Beavertail Pond showing trees laid along shoreline for fish habitat.

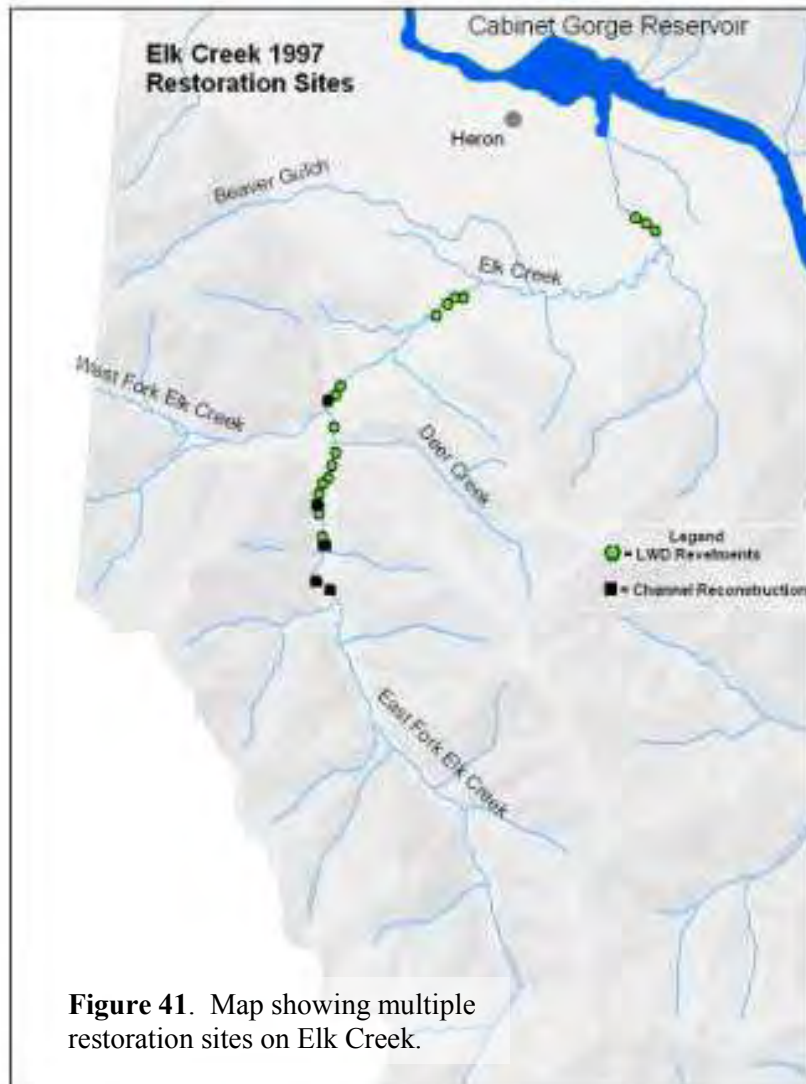
Figure 41. Map showing multiple restoration sites on Elk Creek.

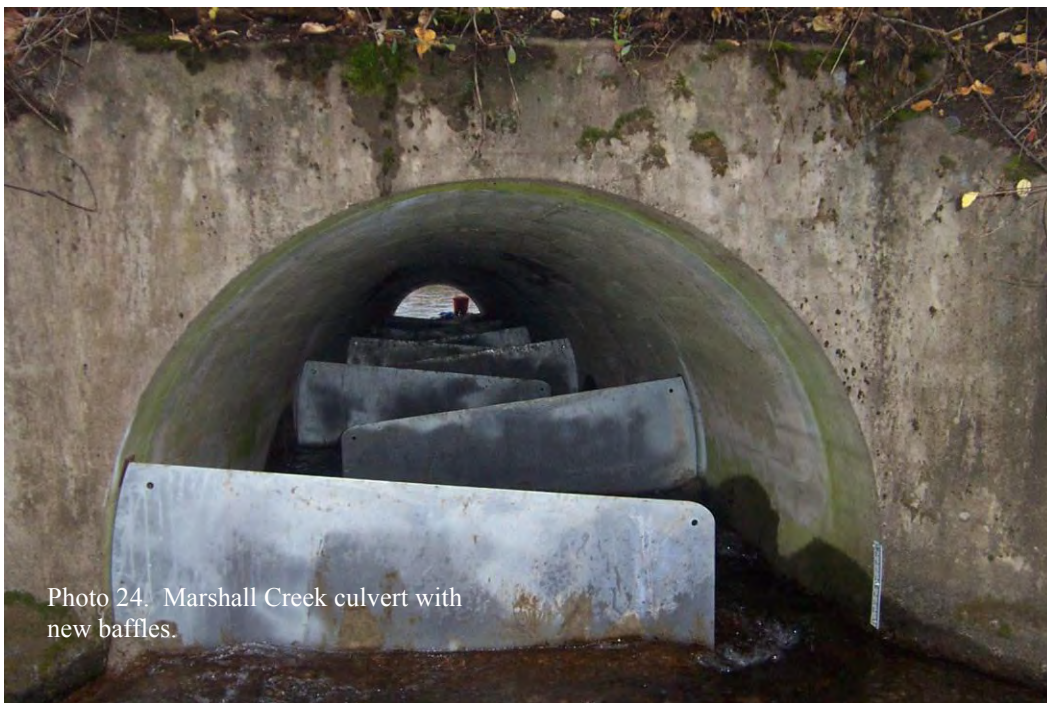
Photo 24. Marshall Creek culvert with new baffles.

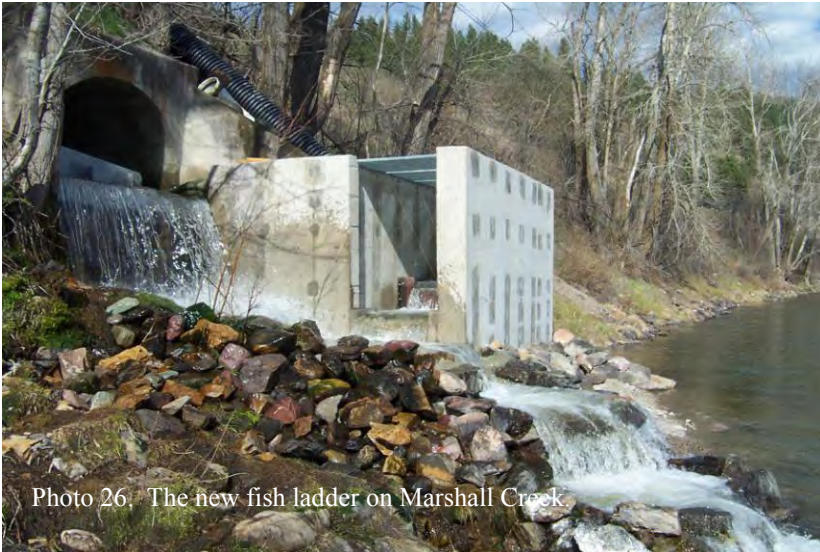
Photo 26. The new fish ladder on Marshall Creek.

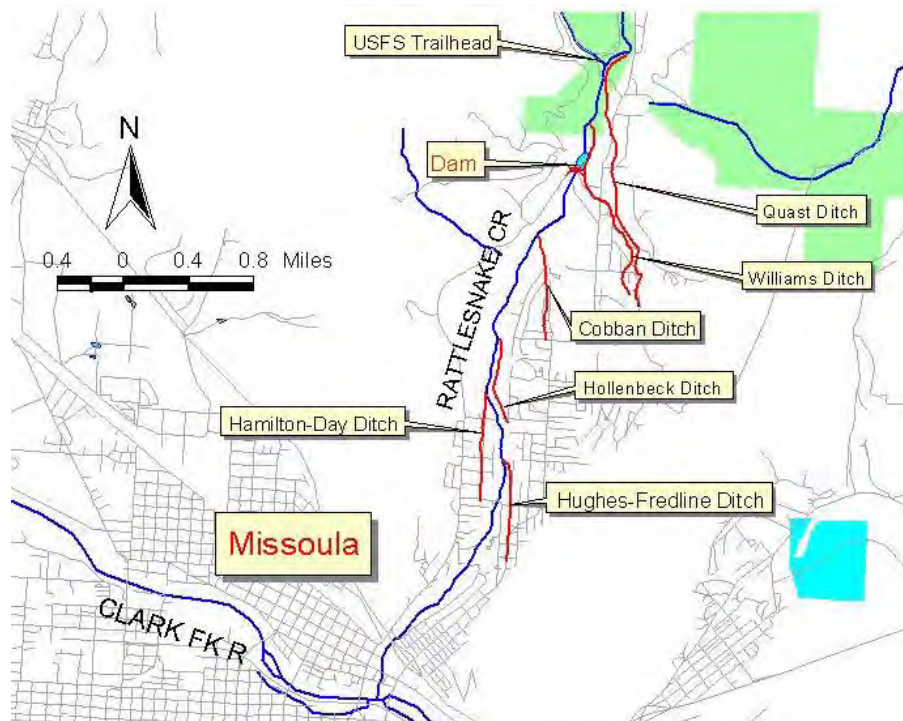
Figure 43. Irrigation diversions in lower Rattlesnake Creek.

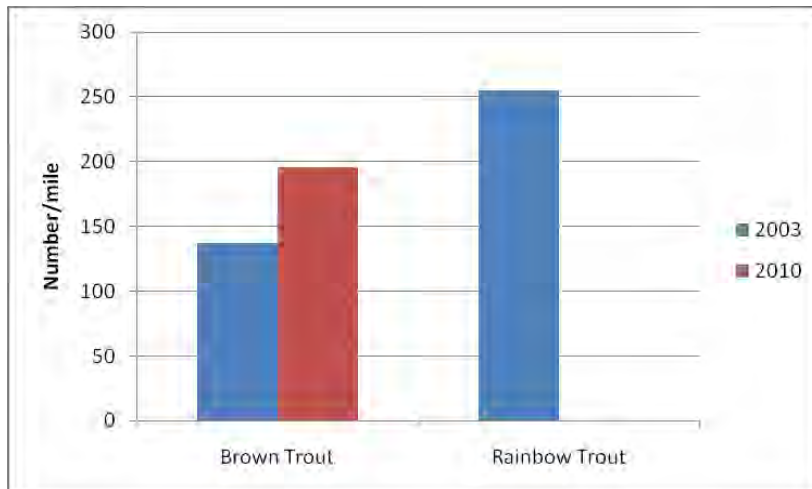
Figure 50: Population estimates (fish per mile) for brown and rainbow trout at the Burnham Ranch section on Prickly Pear Creek.

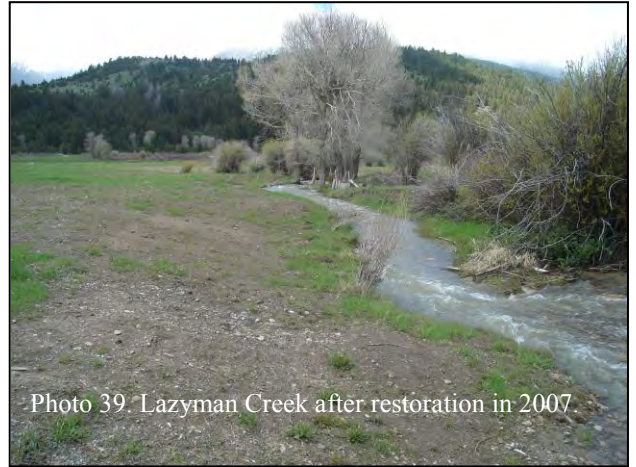
Photo 39. Lazyman Creek after restoration in 2007.

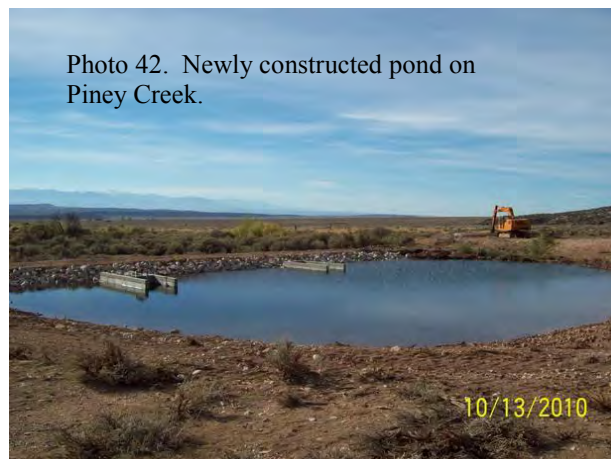
Photo 42. Newly constructed pond on Piney Creek.

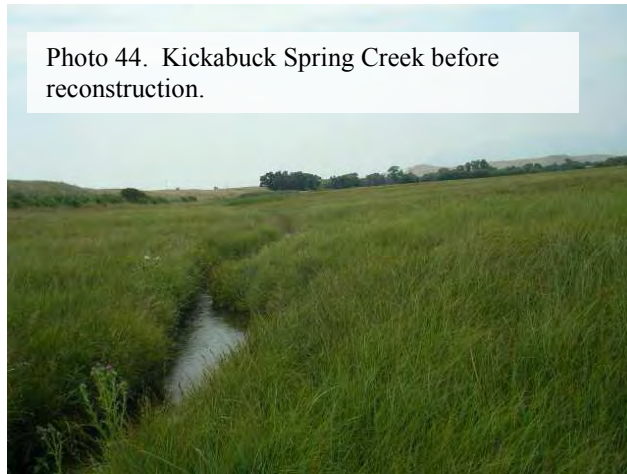
Photo 44. Kickabuck Spring Creek before reconstruction.

7. Kickabuck Spring Creek Spawning Habitat Enhancement. Kickabuck Spring Creek (Sweet Grass County), a tributary to the Yellowstone River near Big Timber, had the potential to provide spawning and rearing habitat for Yellowstone cutthroat trout. Past livestock grazing practices contributed to the degradation of the existing channel. This project involved narrowing and deepening the existing channel, increasing sinuosity, and placing appropriately sized gravel to create approximately 1,400 feet of spawning and rearing habitat. The lessees are in the process of developing a grazing management strategy to protect the stream. **Completed.**

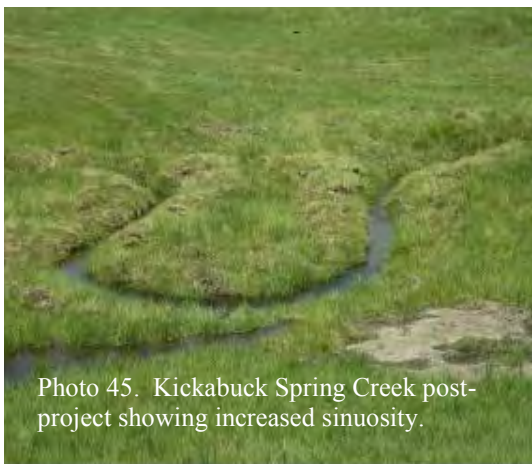
Photo 45. Kickabuck Spring Creek post-project showing increased sinuosity.
